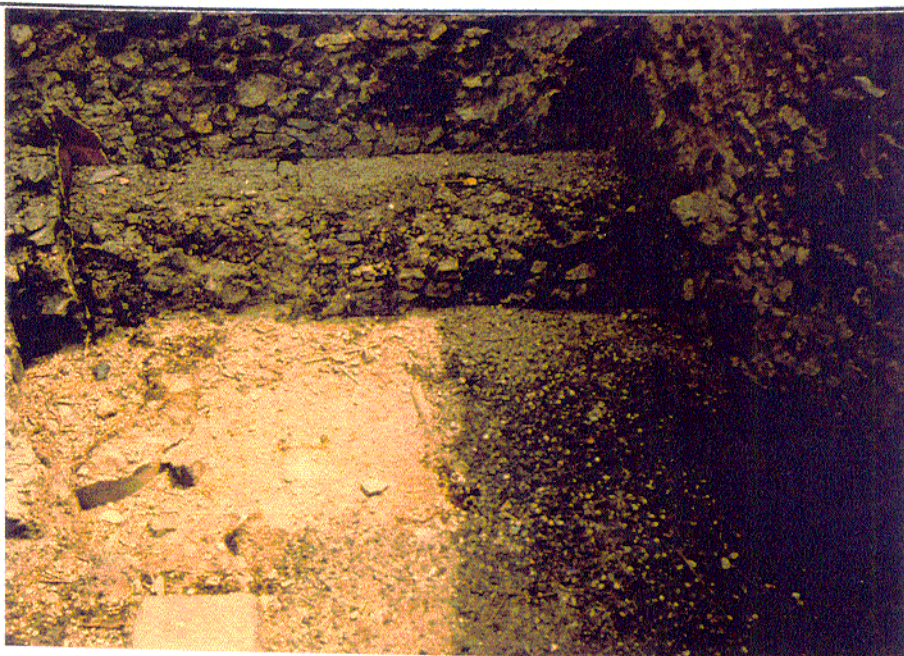
5.126 Caupona di N. Fufidius Successus I.8.15-16: detail E at solid stove in kitchen (5), with drain at left and mortar at right.

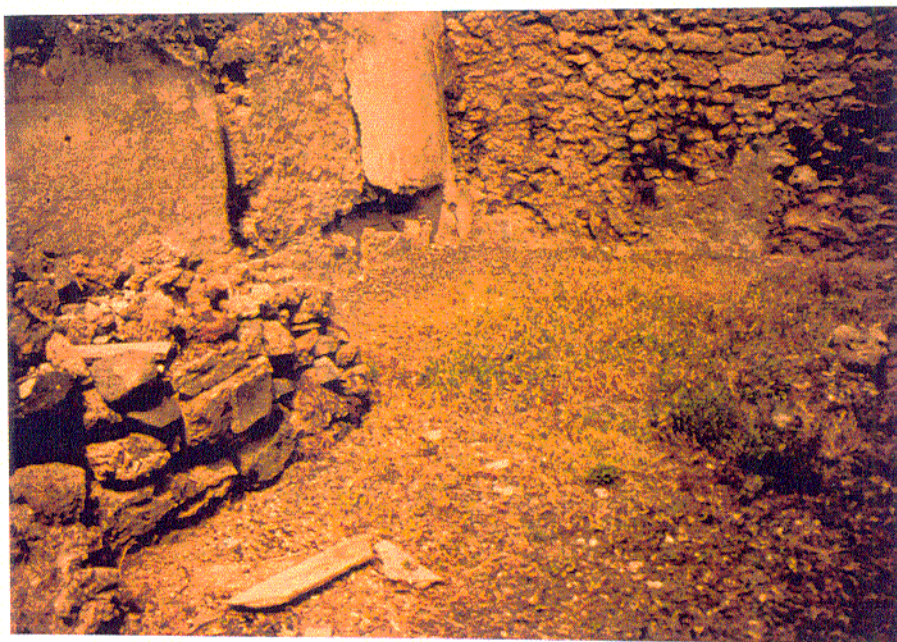
5.127 Caupona di N. Fufidius Successus I.8.15-16: view NW in dining room (6) at the couch niche in that corner. The pile of rubble at left is a modern construction.

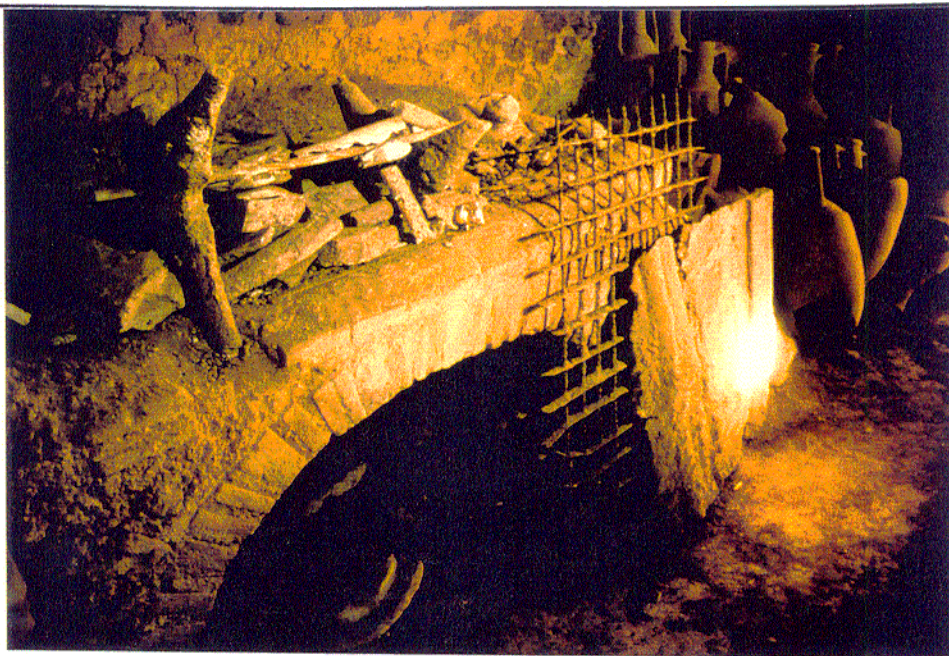
5.128 Casa dei Quattro Stili I.8.17+11: detail SE at one-arched stove in kitchen (21), used now for modern storage of amphorae and other items.

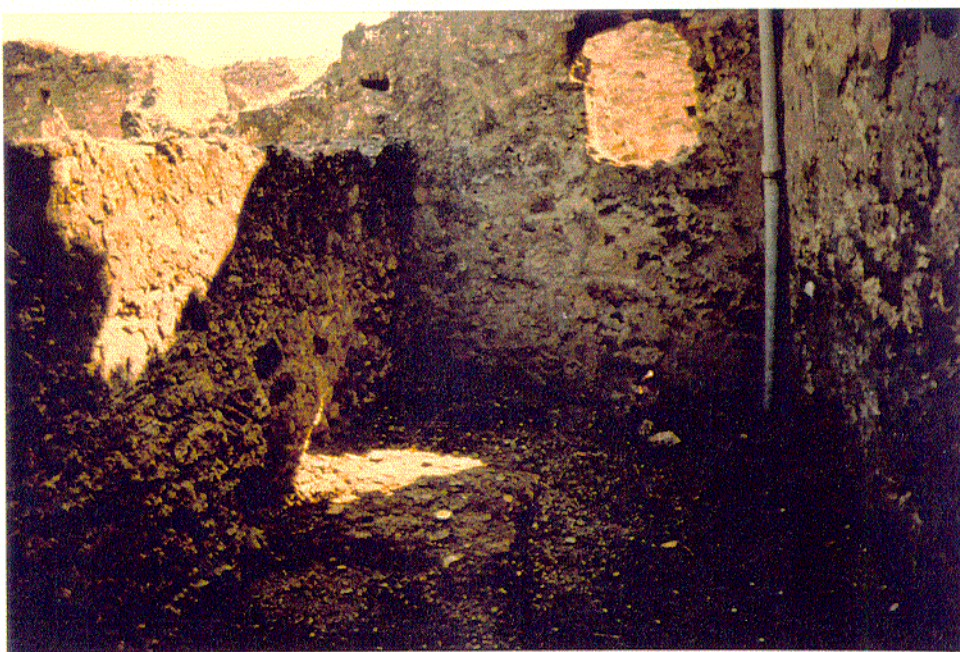
5.129 Casa dei Quattro Stili I.8.17+11: view W at the low remains of a stove podium along the S wall of the former kitchen (5).

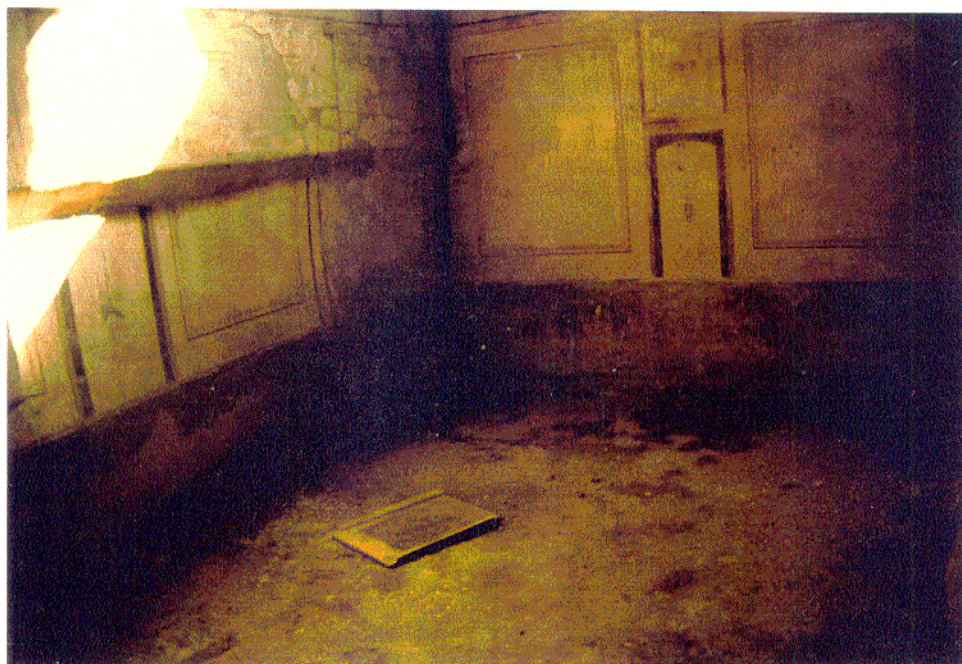
5.131 Casa dei Quattro Stili I.8.17+11: view W in dining room (14) with a couch niche in the S wall.

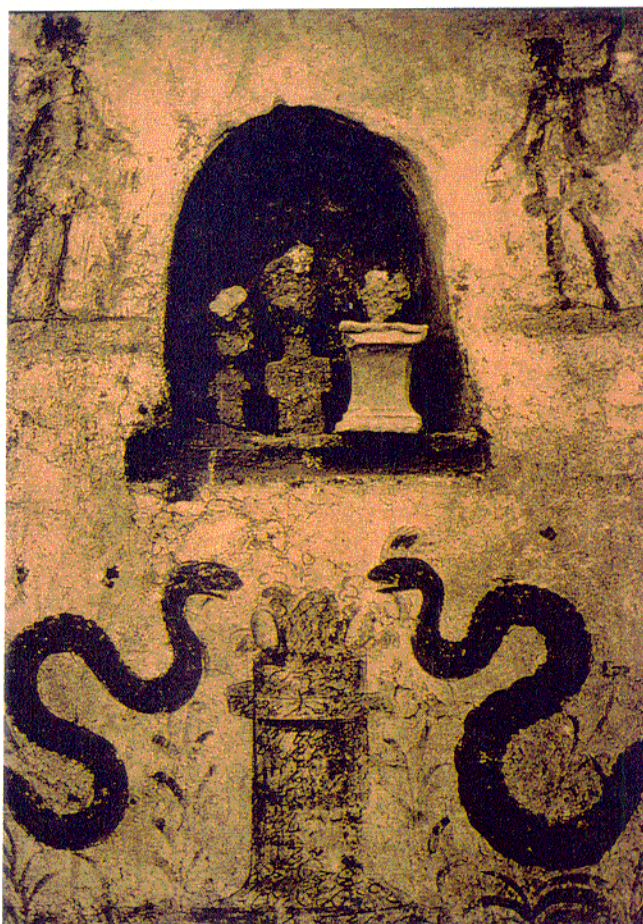
5.133 Casa di Balbus I.8.18: detail of painted niche shrine containing ritual figurines, as found at time of excavation, located in the S wall of kitchen (8) (PPM I, 853, #13).

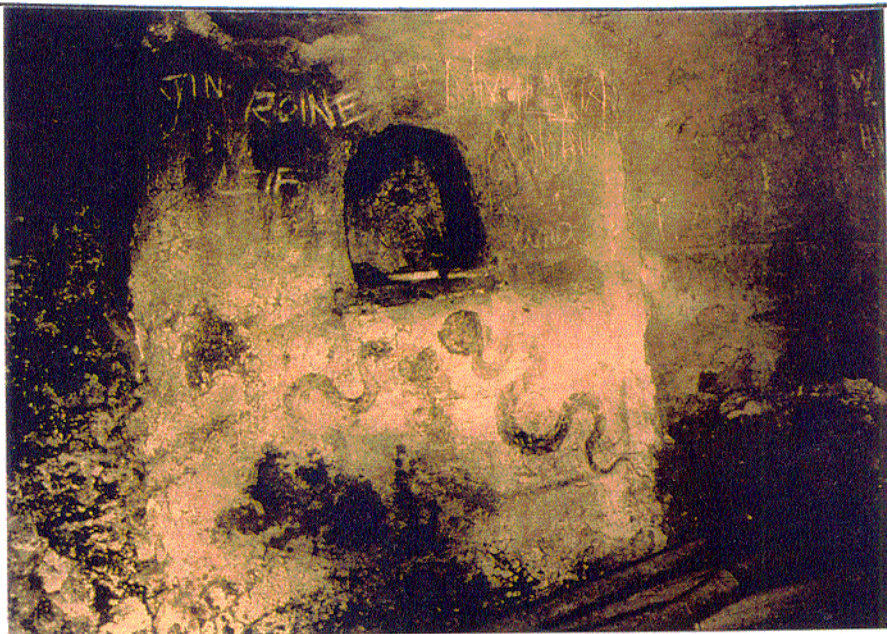
- 5.134 Casa di Balbus I.8.18: view taken in 1977 of the same painted niche shrine as Fig. 5.148, located in the S wall of kitchen (8). The shrine is substantially damaged and no longer contains the figurines (PPM I, 918, #7).

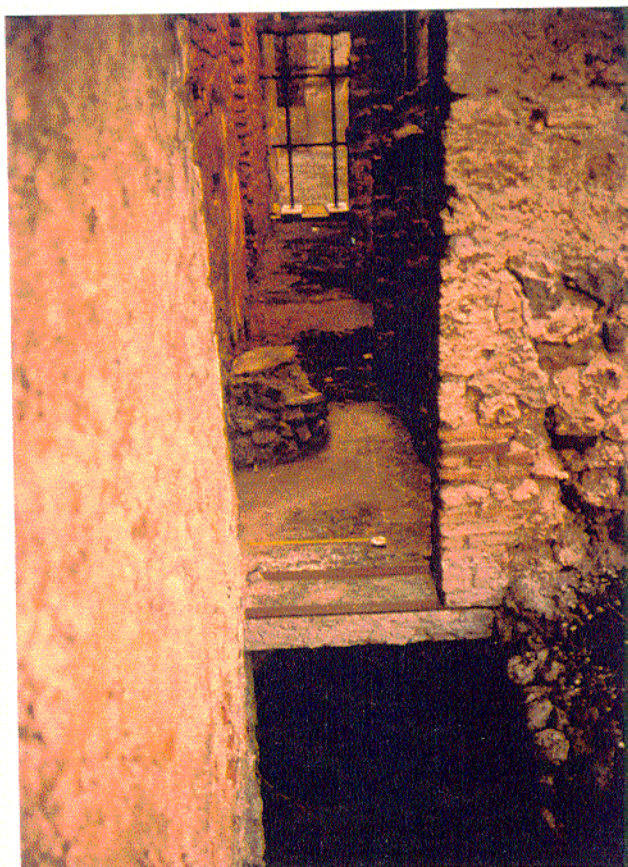
- 5.135 Casa del Bell'Impluvio I.9.1-2: detail N over stair to underground space (15), into kitchen (6), with hearth against the W wall. Scale 0.50 m.

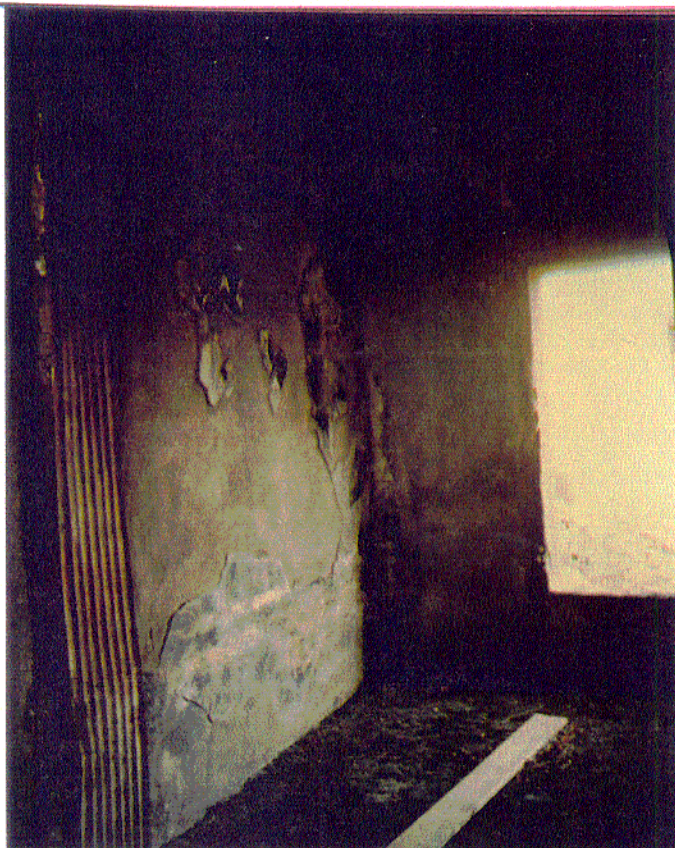
5.136 Casa del Bell'Impluvio I.9.1-2: view SE inside dining room (8), with stucco pilaster defining the division of the room into serving and dining areas.

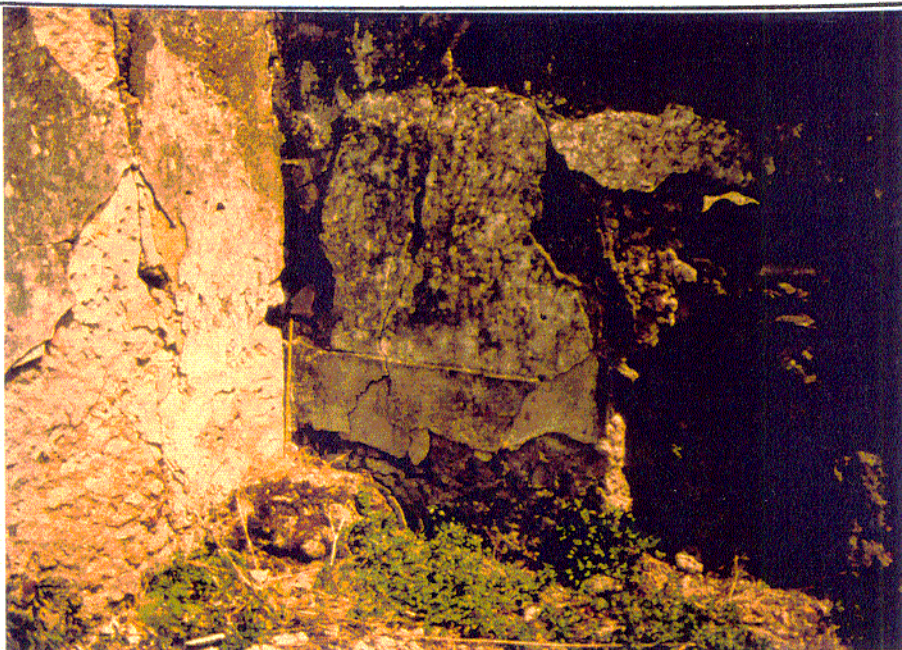
5.138 Casa di Successus I.9.3-4: view SE in the corner of room (10) at supports for possible stove. Scale 0.50 m.

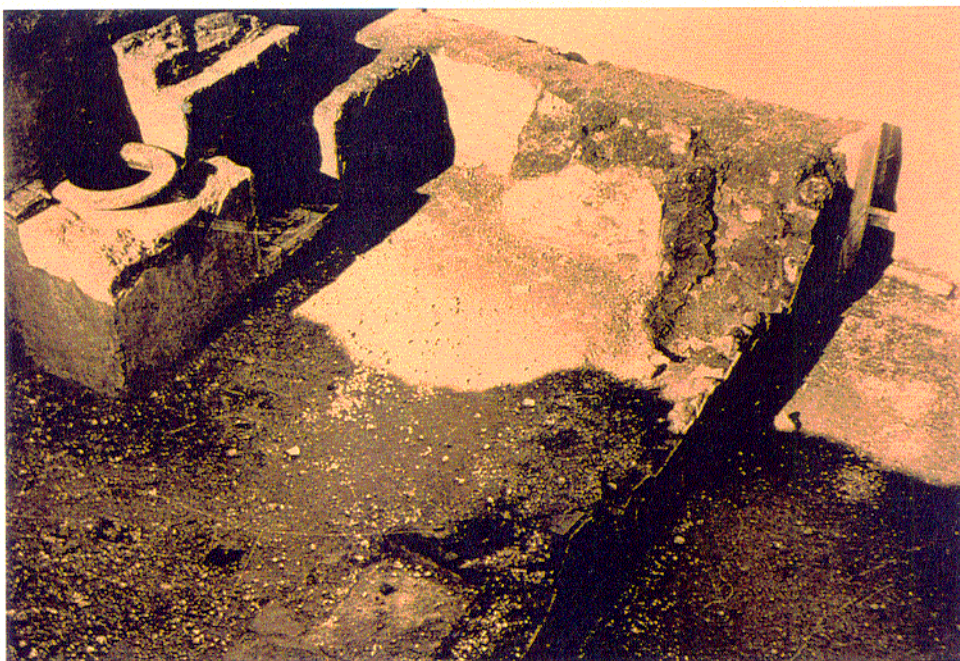
5.139 Casa di Successus I.9.4: view NW at serving counter of diner attached to the house (PPMI, 465, #1).

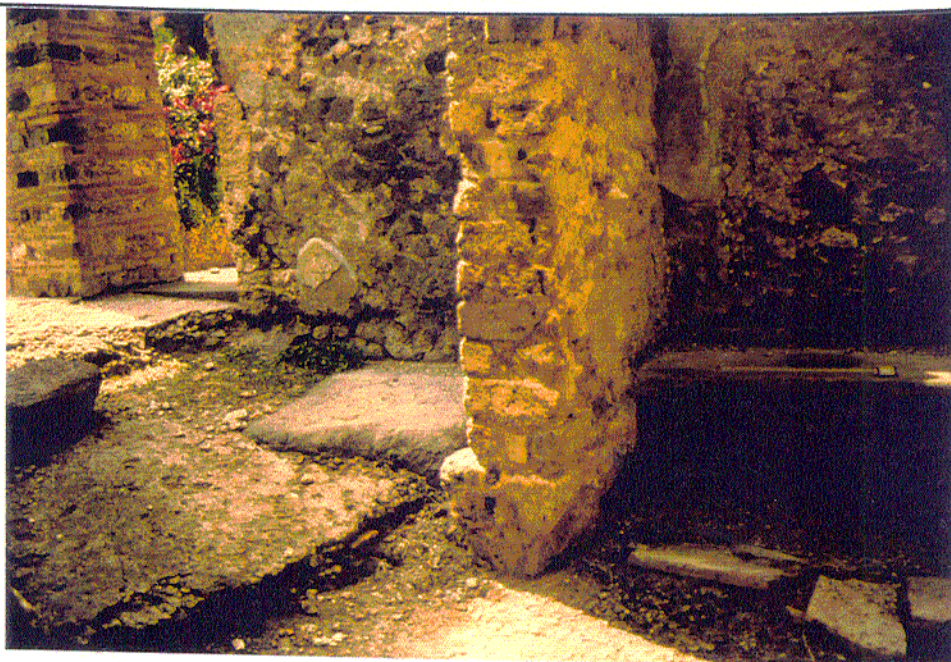
5.140 Casa dei Cubicoli Floreali I.9.5-7: detail N at latrine in (15), right, and possible cooking area in (16), left. Scale 0.50 m.

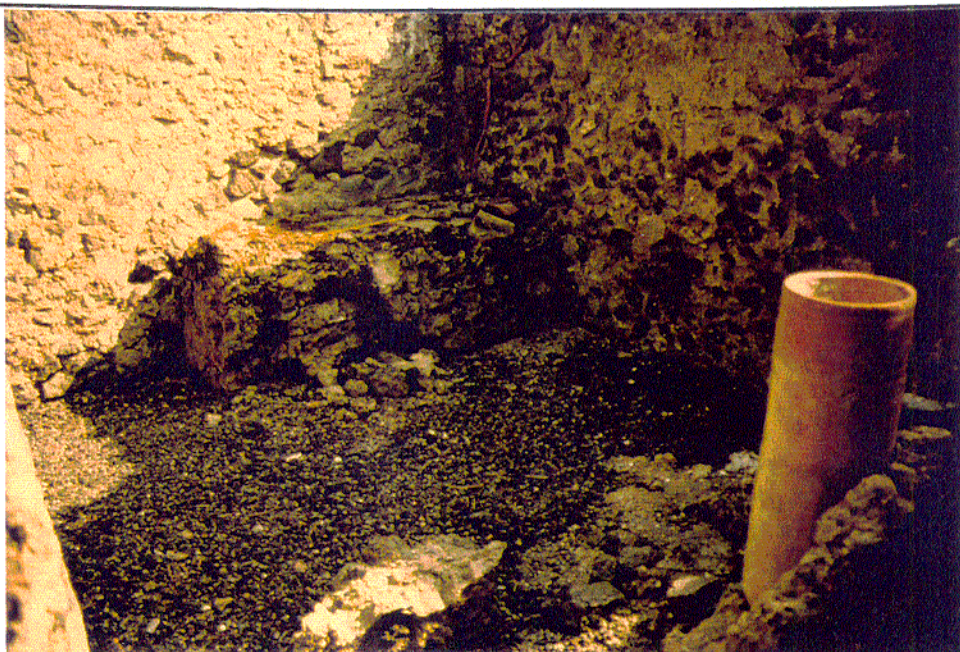
5.144 Casa I.9.8: view SW in kitchen (7) and solid stove. Drain pipe immured in wall at right. Scale 0.50 m.

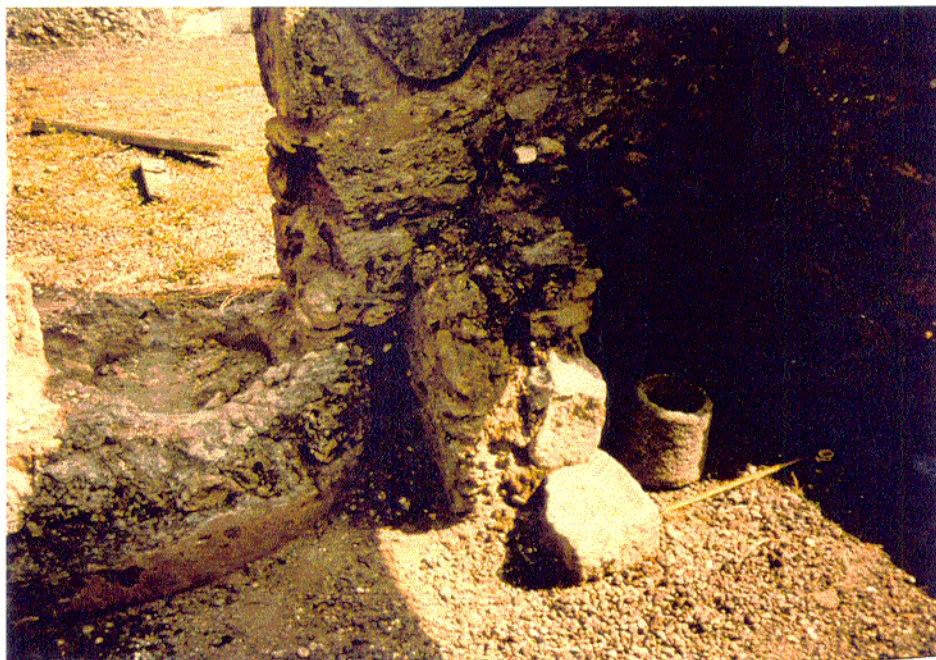
5.145 Casa I.9.9: detail S at masonry support and beam holes for stove in corridor (4), next to a cistern head. Two mortars lie in the area of the stove. Scale 0.50 m.

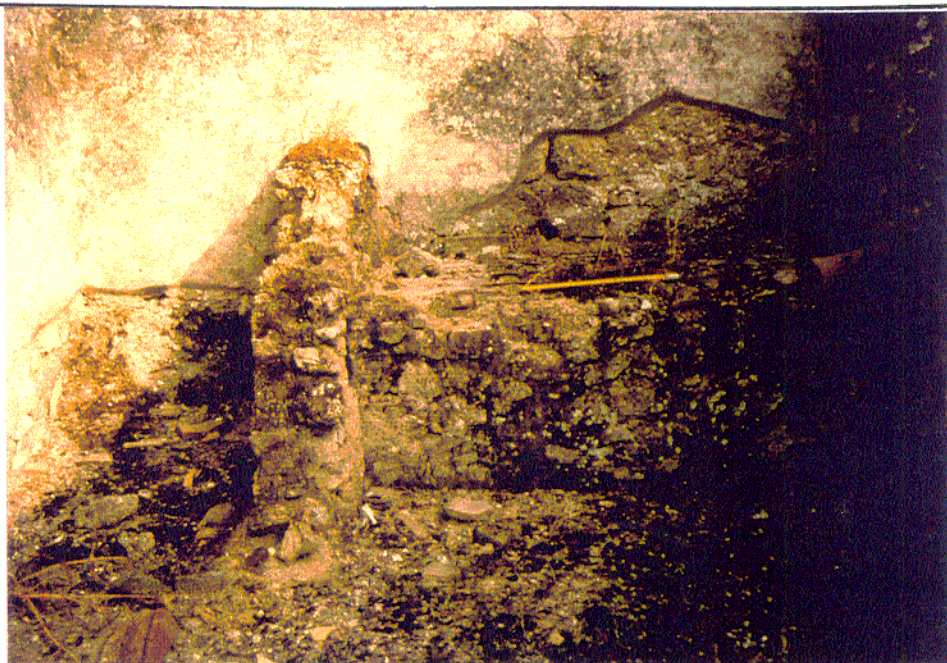
5.146 Casa I.9.10: view S at solid stove, right, and latrine, left, in kitchen (2). Scale 0.50 m.

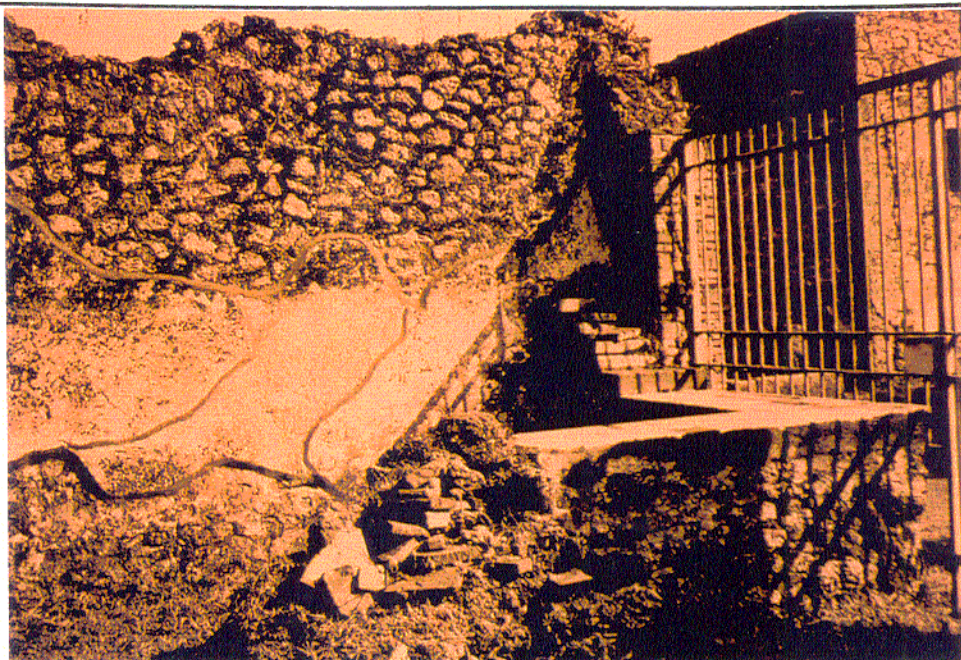
5.148 Caupona di Amarantus I.9.11: view SE at serving counter on the street; a ruined hearth remains at the end of the counter (PPM II, 148, #3).

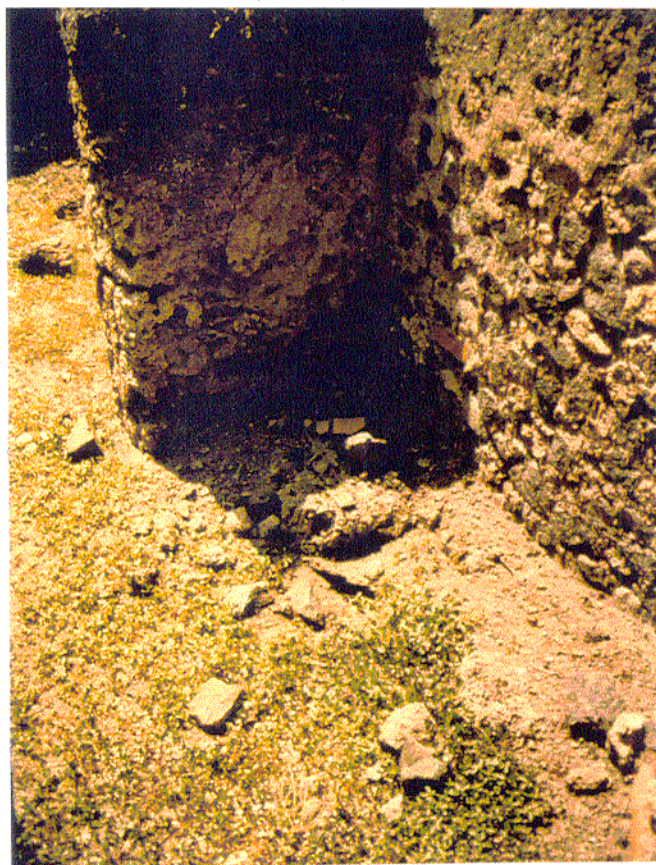
5.149 Caupona di Amarantus I.9.11: view SW within room (3) at partially buried masonry benches.

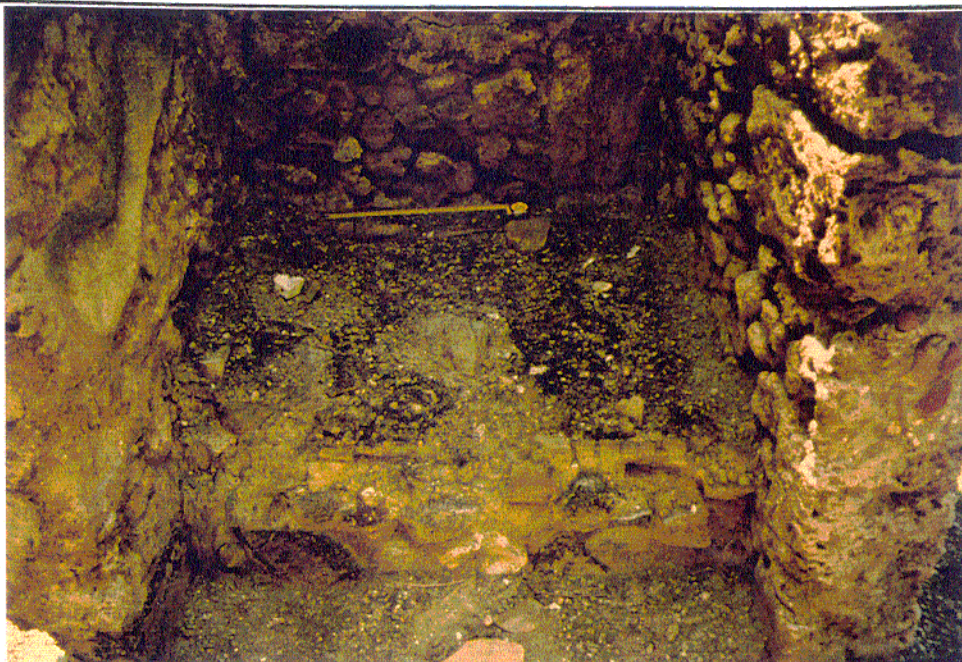
5.150 Casa I.9.12: detail S at solid masonry hearth in kitchen (9). Scale 0.50 m.
